1426-1446 East Baltimore Street (Commercial Buildings)
1434 East Baltimore Street
Baltimore (Independent City)
Maryland

HABS No. MD-904-D

WRITTEN HISTORICAL AND DESCRIPTIVE DATA

ARCHITECTURAL DATA FORM

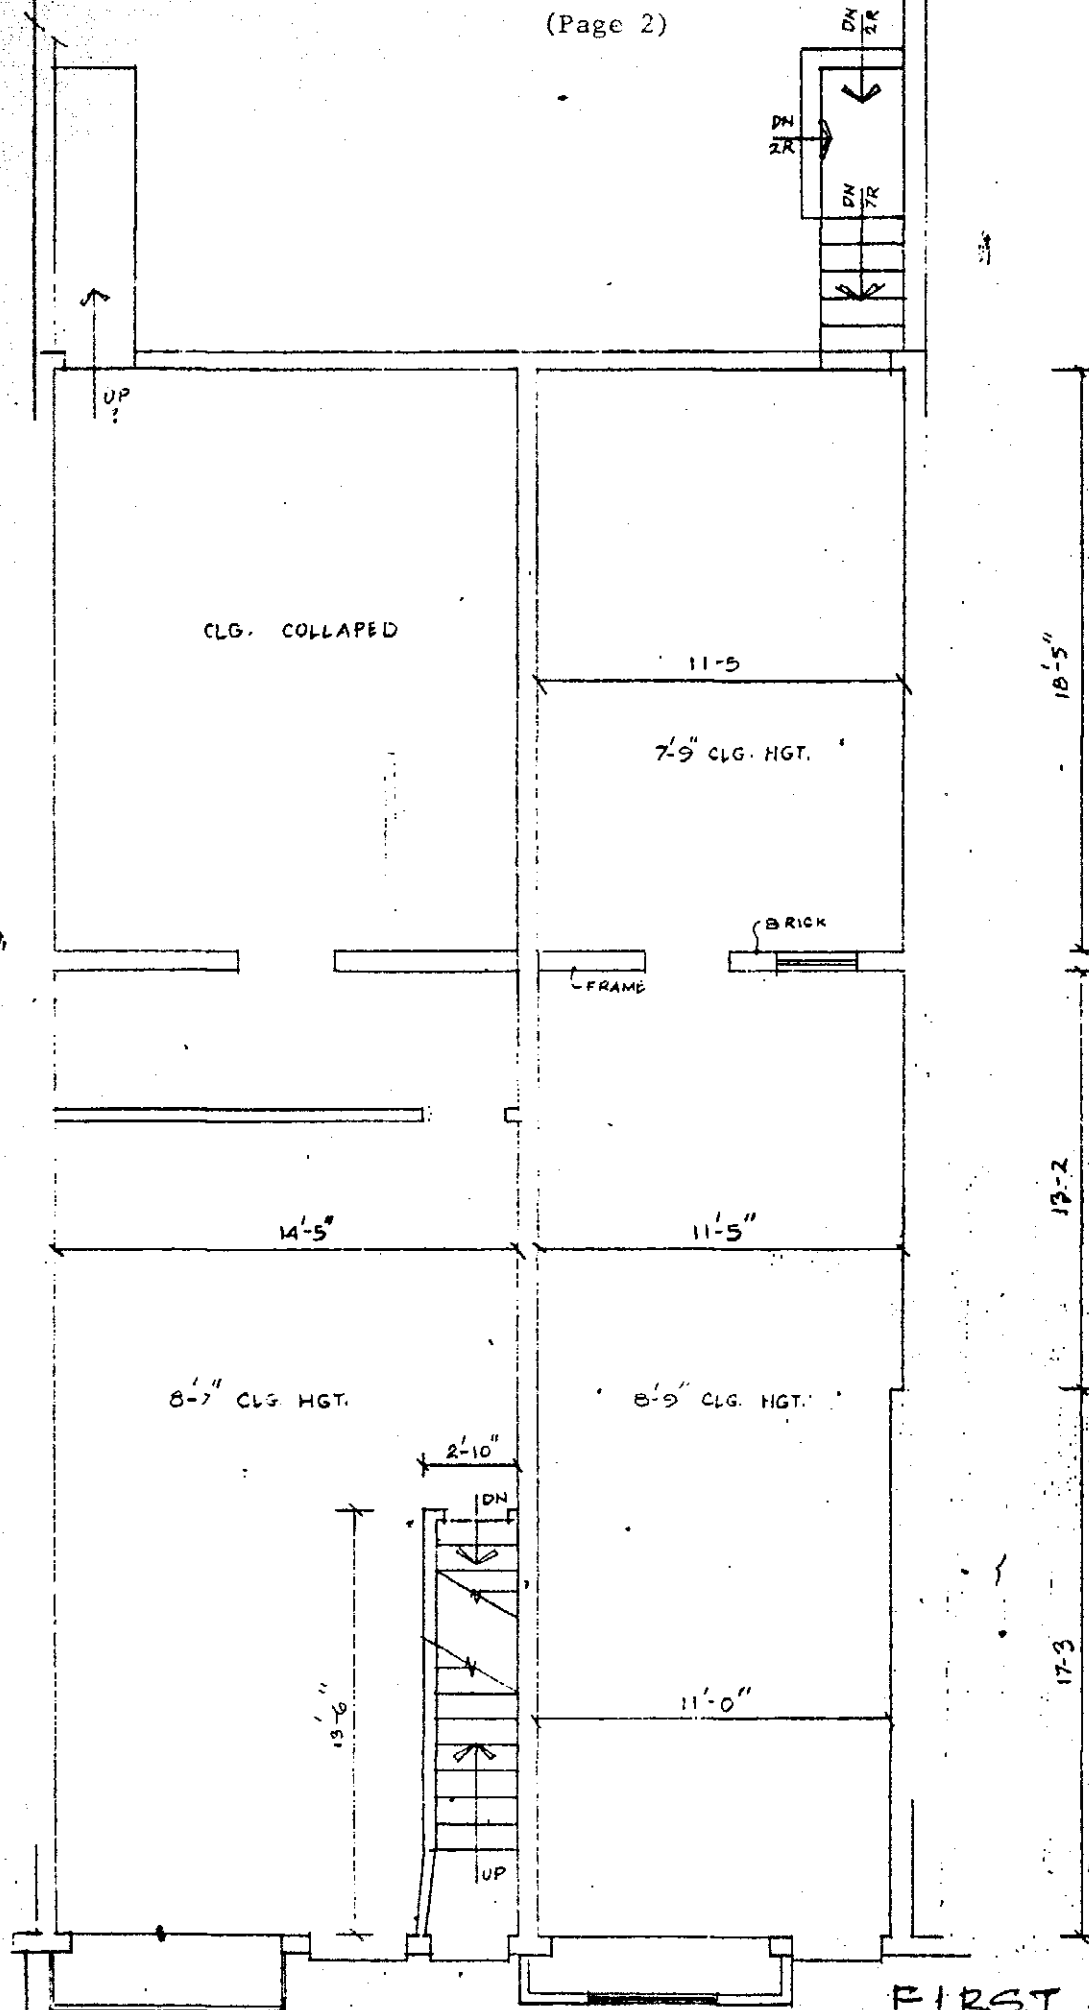
FIRST FLOOR

SIZE AND DIMENSIONS OF STRUCTURE (SKETCHED FLOOR PLANS ON SEPARATE PAGES ARE ACCEPTABLE) Overall 16' x 50' Front 16' x 30' Rear-- x 20' (see sketch plan)			
EXTERIOR FEATURES OF NOTE Wood cornice; wood cornice above storefront. Red brick, common bond. Segmental-arched window openings.			
INTERIOR FEATURES OF NOTE (DESCRIBE FLOOR PLANS, IF NOT SKETCHED) Undeterminable			
MAJOR ALTERATIONS AND ADDITIONS WITH DATES Rear shed addition circa 1920 (now demolished). Storefront alterations			
PRESENT CONDITION AND USE Currently vacant, this building is suffering from extensive water damage. It is unsafe to enter and inspect. Building front appears stable.			
OTHER INFORMATION AS APPROPRIATE For photographs, see HABS No. MD-904. Building is to be demolished behind the front room and rebuilt to a new design for cooperative apartments for artists.			
SOURCES OF INFORMATION (INCLUDING LISTING ON NATIONAL REGISTER, STATE REGISTERS, ETC.) 1869 Sachsey Map, 1887 Bromley Map, Sanborn Maps 1902, 1911, 1927, 1932

1434-1436
E. Baltimore St.
Baltimore, Md.
